# SALT MARSH RESTORATION TECHNIQUES AND RESEARCH AT PARKER RIVER NWR

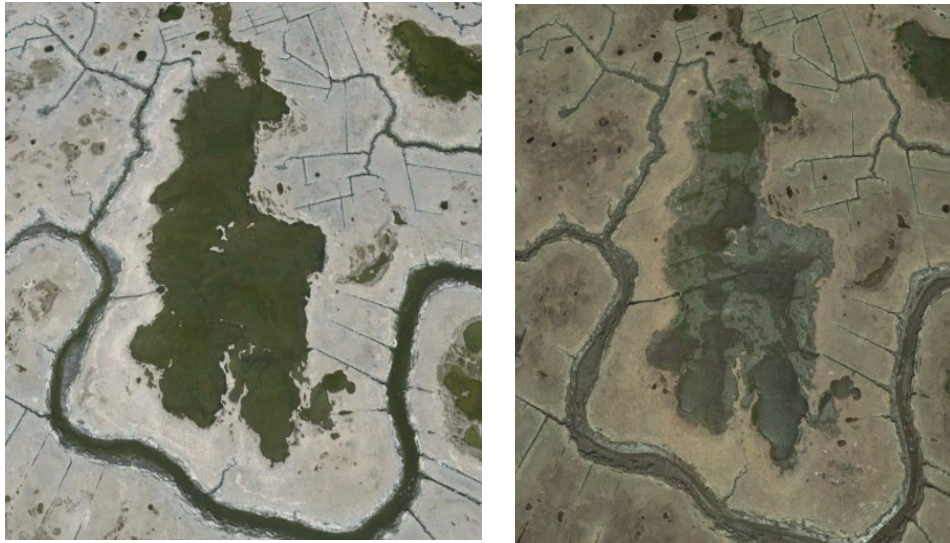
In the example below, about 60 percent of the large pool is drained through the runnel, creating multiple smaller pools.

Figure 1. Aerial photo of a megapool prior to runneling (left, 2013) and after runneling in 2015 (right, 2019)

**Results to Date:** Runneling was effective in partially draining pools and exposing pool edges (particularly during neap tides). Following runneling, both *S. alterniflora* and *S. patens* began to recolonize exposed pool edges within a few months. Single-season survival of transplanted *S. alterniflora* ranged between 45 and 85 percent at two experimental sites (Burdick et al. 2017). However, recolonization also occurred quickly in the absence of transplants, indicating the additional effort and disturbance is unnecessary. Vegetative cover also increased substantially the year after runneling.

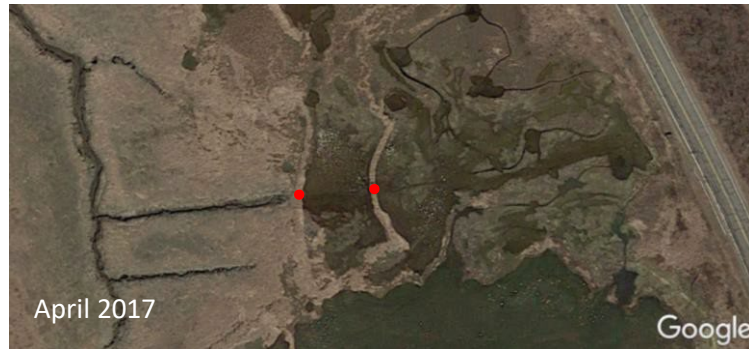
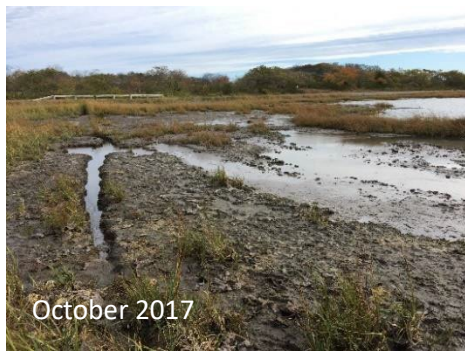
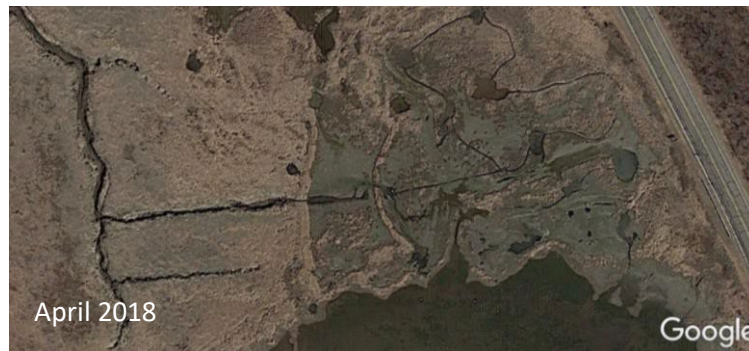
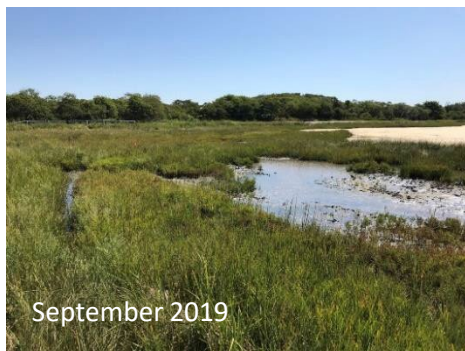
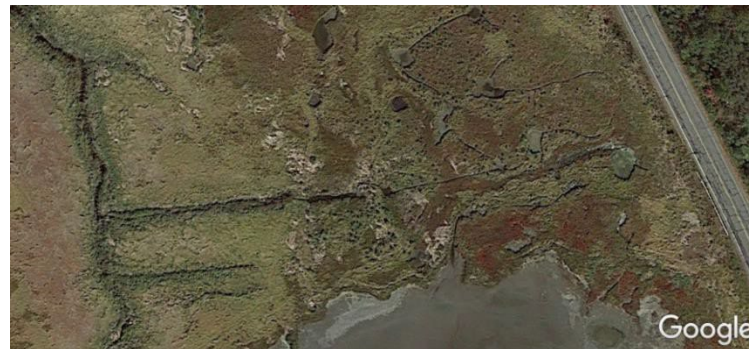
**Example:** In May 2017, we removed two ditch plugs near the north end of the Salt Pannes Observation Area, a high visitor use area along the Refuge Road. The plugs were impounding water on the marsh surface, creating new pools and killing vegetation. After removing ditch plugs, the pools drained almost immediately. Within two years, the pools and surrounding areas were densely vegetated with a

combination low marsh and high marsh species.

Figure 2. Aerial and on-the-ground imagery of the ditch plug removal site north of the Salt Pannes before and after restoration in May 2017. Aerial images are from Google Earth.

**Results to Date:** Ditch plug removal quickly drained flooded areas, as indicated by water loggers. Immediately after removal, water drained from the marsh almost 20 cm more than during pre-restoration. Vegetation also recolonized mudflats quickly. In vegetation plots near ditch plug removal sites, bare mud slightly decreased while *S. alterniflora* slightly increased during the first two years following restoration. However, the scale of marsh response and revegetation was best captured through aerial imagery and photo stations. (See example projects below.)

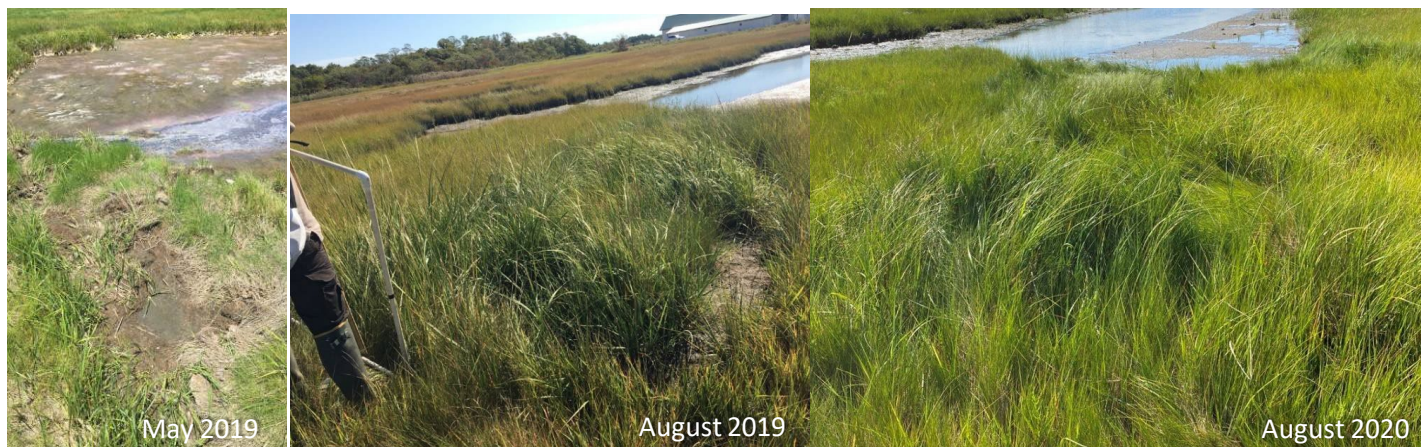
**Example:** In this example below, the microtopography island was vegetated with 60% *S. alterniflora* and 40% *S. patens* 3 months after creation. The following year, the vegetation was 80% *S. patens* and 20% *S. alterniflora*, with 60% thatch. It supports the vegetation structure and elevation to support nesting sparrows.

Figure 3. Microtopography island in the sub-HQ marsh, showing quick revegetation and development of vegetation structure capable of supporting nesting salt marsh sparrow.

**Results to Date:** We constructed microtopography islands in 2019, and each island was mostly or completely vegetated by the summer of 2020. We did not need to directly seed any of the islands. They were primarily colonized by desirable high marsh species (*S. patens*) and appeared potentially suitable for saltmarsh sparrow nesting. Although we observed saltmarsh sparrow activity around the islands, we did not detect any nests, and we are unsure whether these higher elevation patches could increase predation risk.

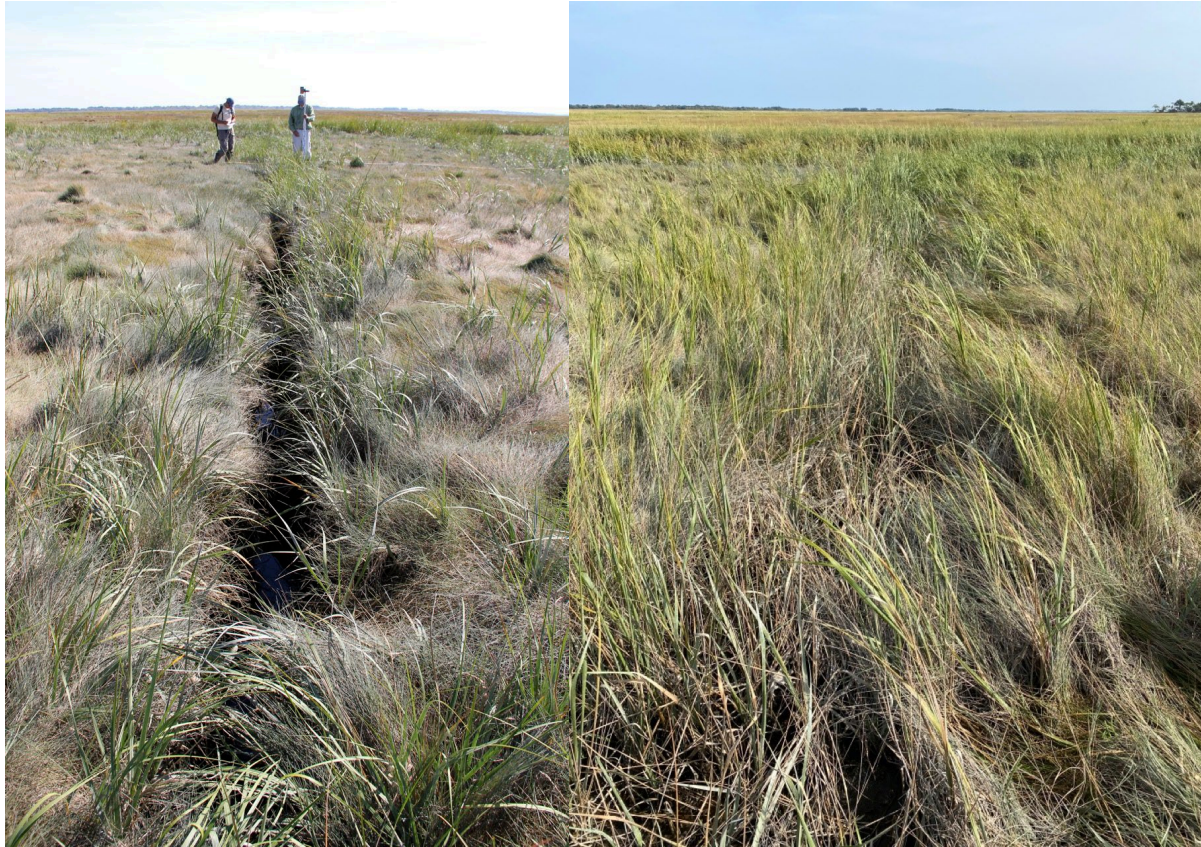
**Example:**

**Results to Date:** Over the first three years following ditch remediation, treated ditches became shallower and more vegetated. The only species that colonized remediated channels was *S. alterniflora*, which increased in percent cover and stem density. Some small, shallow ditches have completely healed and is colonized by *S. patens*. Most ditches are colonized by *S. alterniflora* and are 20-30 cm below marsh surface. In our earliest pilot sites, there is marsh platform inundation in between the healed ditches. These areas will be advanced, using runnels to create the single-channel hydrology. Ditch Remediation technique has been adapted in the later treatments to avoid inundation of adjacent marsh platform.

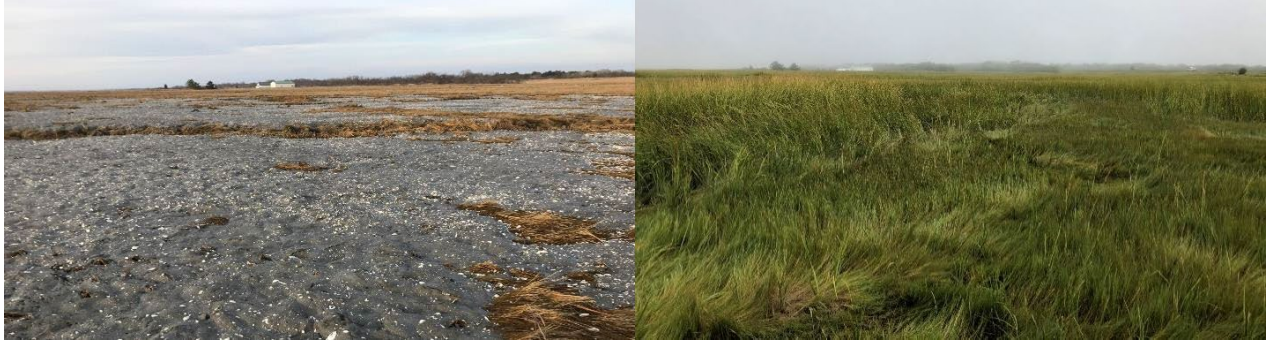
Figure 5. Photos of the sediment deposition site taken from a similar vantage point in May 2018 (left) and September 2018 (right).

**Description:** Large volumes of sediment sometimes settle on the salt marsh surface during storms. A particularly large sediment deposition event occurred in the winter of 2018, when ice rafts froze to the mudflats in Plum Island Sound and then drifted onto the adjacent marsh (Figure XX). The ice rafts deposited more than 24 ha of sediment at an average depth of approximately 26 mm, nearly ten times more than the background accretion rate (Moore et al. 2019). This event provided a unique opportunity to assess the impacts of large-scale sediment deposition on the salt marsh and inform potential restoration efforts. Specifically, natural sediment deposition events are similar to “thin layer deposition,” a marsh restoration technique utilized mostly in the Mid-Atlantic but not in New England. Thin layer deposition applies dredged material directly to degraded marsh surfaces to increase elevation and resilience.

**Results to Date:** Following the 2018 growing season, the percent cover of vegetation was significantly lower in sediment deposit areas compared to control areas (Moore et al. 2019). However, percent cover still exceeded 70%, and species composition did not change, suggesting negative impacts to marsh vegetation are short-lived (Moore et al. 2019). Soil conditions were also similar in sediment deposit and control areas (Moore et al. 2019). Site visits with David Burdick in 2021 found that the vegetation community has transitioned from one dominated by *Distichlis* (early successional species) to a mixed high marsh composition, including thick *S. patens* patches. Soil samples showed nice root zone formation, and no signs of biogeochemical concerns. Additional monitoring of this event will help with future sediment deposition actions, if needed.

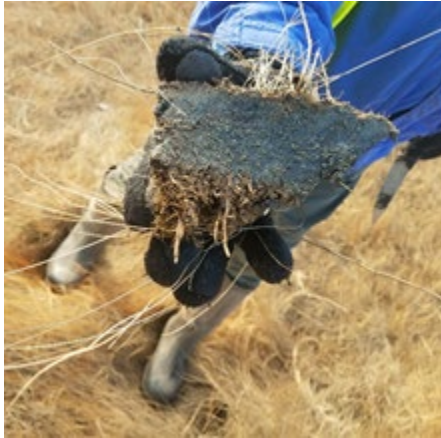
Sediment core taken in November 2021 show vegetation growing through thick sediment deposit. Core taken from area that was deposited with 20+cm of mineral soil from mudflats, that is now covered with thick *S. patens*.
