# 100-acre Marsh Restoration at Parker River NWR

## Monitoring Report, updated April 2023

Prepared by Liana DiNunzio, Amy Kirkey, and Nancy Pau

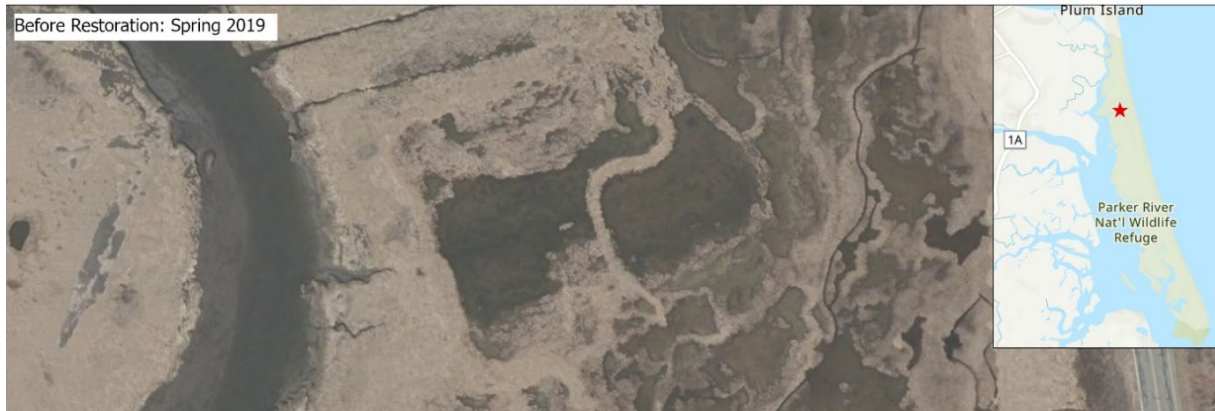
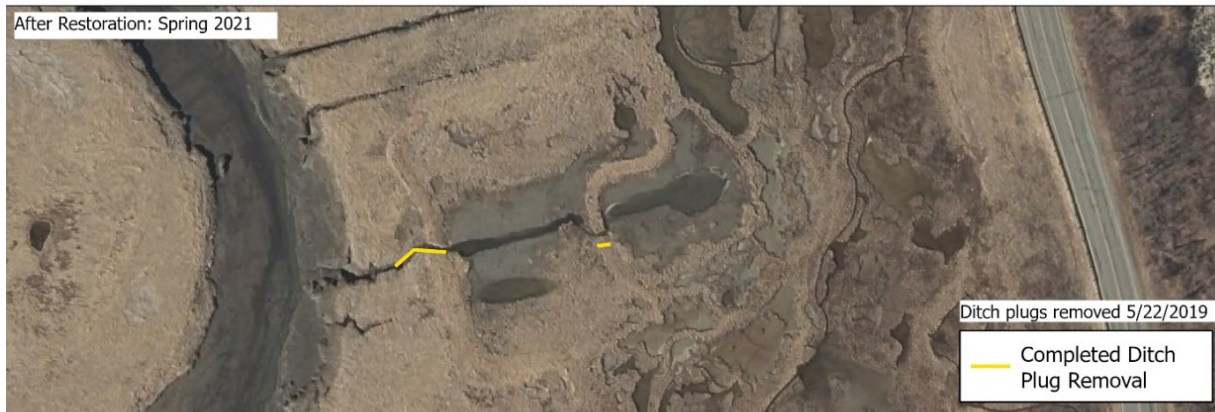
- Example 1: Ditch plug removal was used to address two pools in an area south of the Salt Pannes. The top panel of Figure 5 (below) shows the area before restoration (April 2019), with two pools that are disconnected from tidal flow. Two ditch plugs were removed on May 22, 2019, as shown in the lower panel of Figure 5. This restoration allowed water to flow off the marsh surface, thereby draining the pools, with the tide cycle. A noticeable reduction in the size of the pools following the restoration can be seen in the lower panel of Figure 5, which uses aerial imagery from Spring 2021. Figure 6 shows the revegetation of the drained pools during the growing season (October 2021).

Figure 5. Aerial photos from before and after 2019 ditch plug removal at two pools south of the Salt Pannes (Example 1).

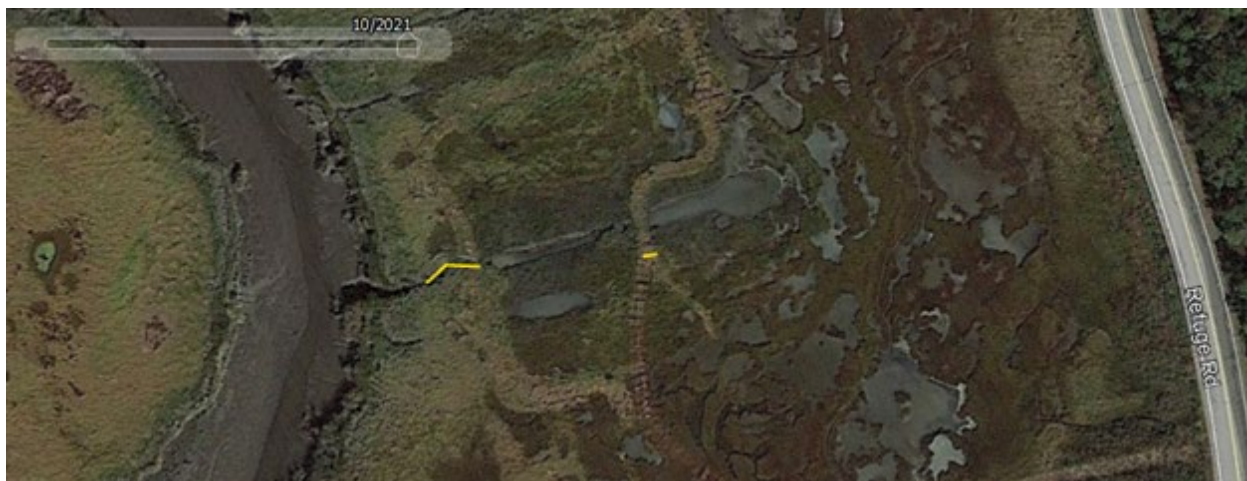
Figure 6. Aerial imagery showing revegetation of the drained pools (Example 1) during the growing season. (Google Earth, October 2021)

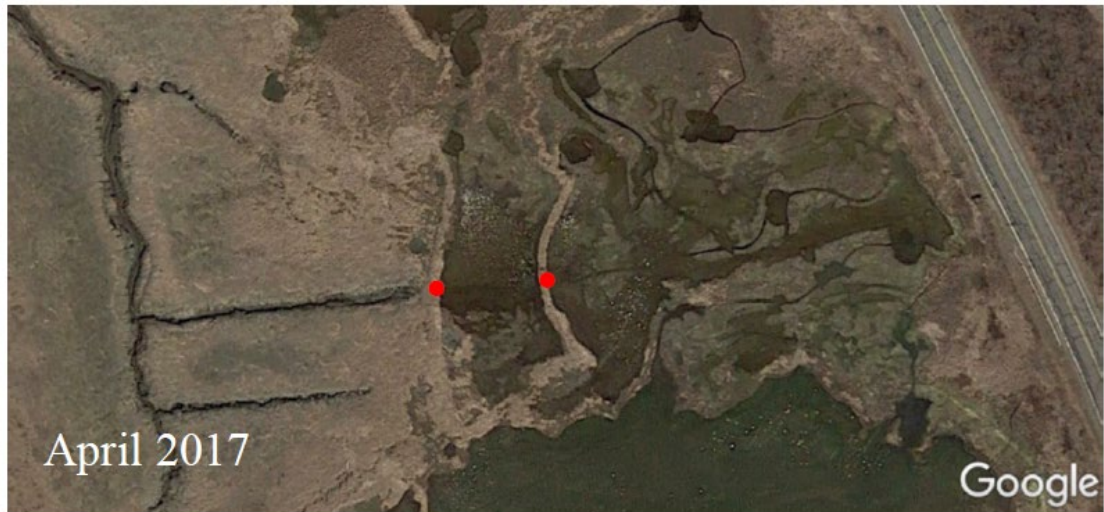
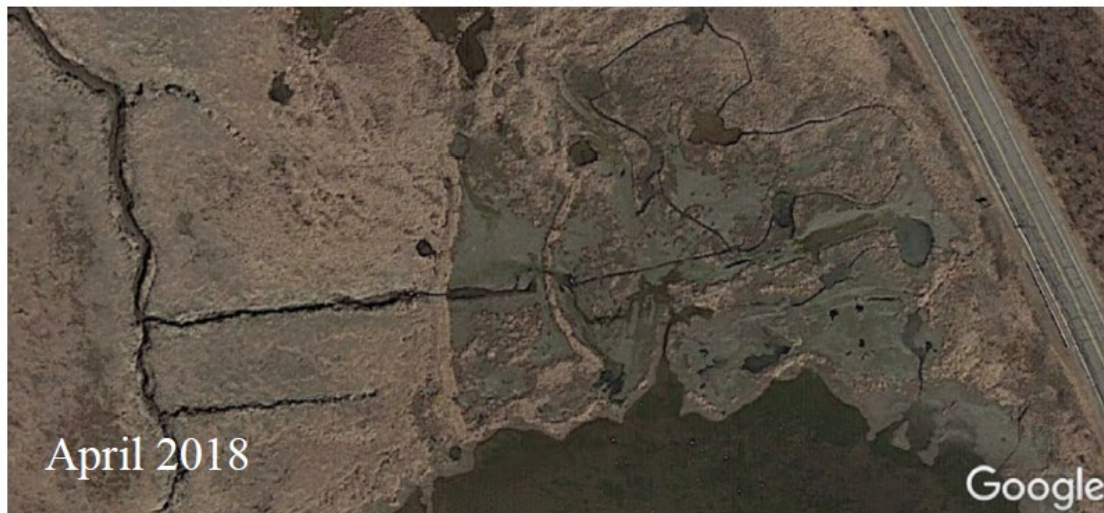
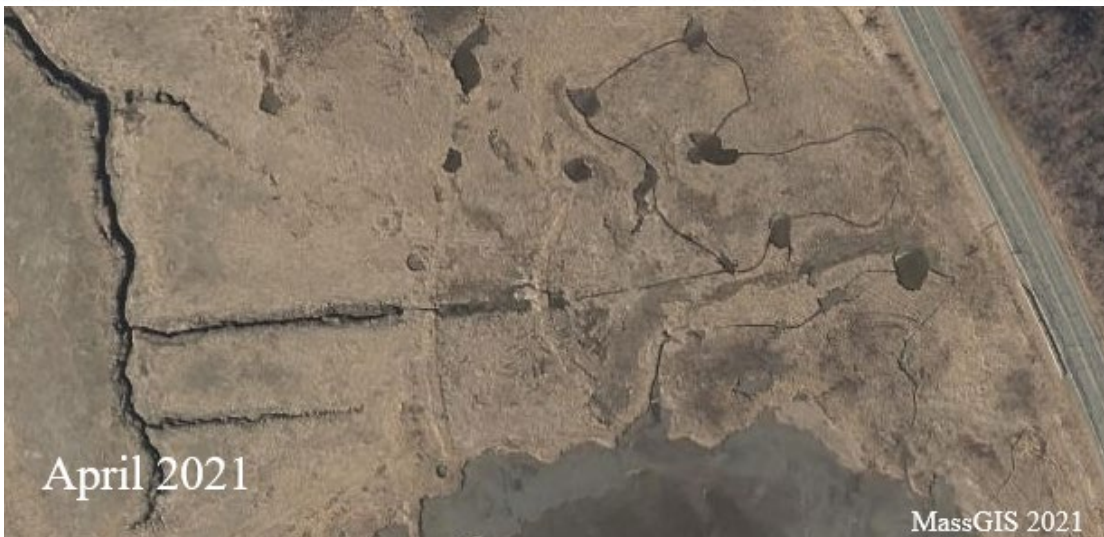
- Example 2: In May 2017, we removed two ditch plugs near the north end of the Salt Pannes Observation Area, a high visitor use area along the Refuge Road. The plugs were impounding water on the marsh surface, creating new pools and killing vegetation (Figure 7 - top panel, 2017). After removing ditch plugs, the pools drained almost immediately (Figure 7 - middle panel, 2018). Within two years, the pools and surrounding areas were densely vegetated with a combination low marsh and high marsh species (Figure 7 - bottom panel, 2021). The ditch plug removals resulted in approximately 12.4 cubic feet of impact to the marsh. This is a small price for the approximately 0.75 acres of marsh restored by this work.

Figure 7. Aerial imagery of the ditch plug removal site (Example 2) before and after restoration in May 2017. The locations of ditch plug removal are marked with red dots. (Google Earth 2017 & 2018; MassGIS 2021)

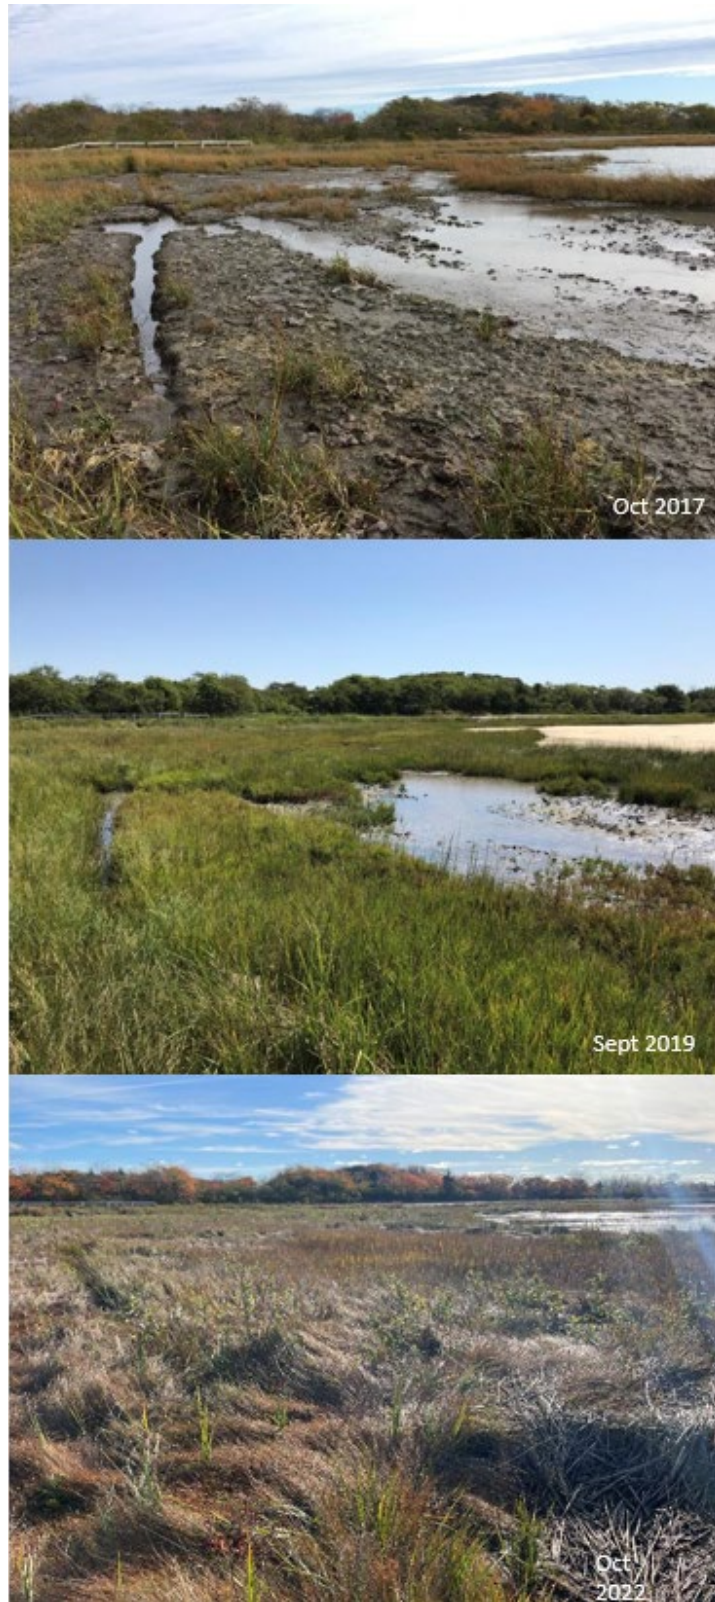
- **Runnels:** Examples 2 and 3 below show the marsh's response to ditch plug removal and runneling. In general, photos show a reduction in marsh surface inundation and bare ground and an increase in vegetation cover after runnels are created or ditch plugs are removed.
  - Example 2 (continued): These on the ground photos correspond to the aerial imagery of Example 2 above. Two ditch plugs were removed in 2017 (see Figure 8).

Figure 8. Photo station imagery of the ditch plug removal site north of the Salt Pannes before and after restoration (Example 2).

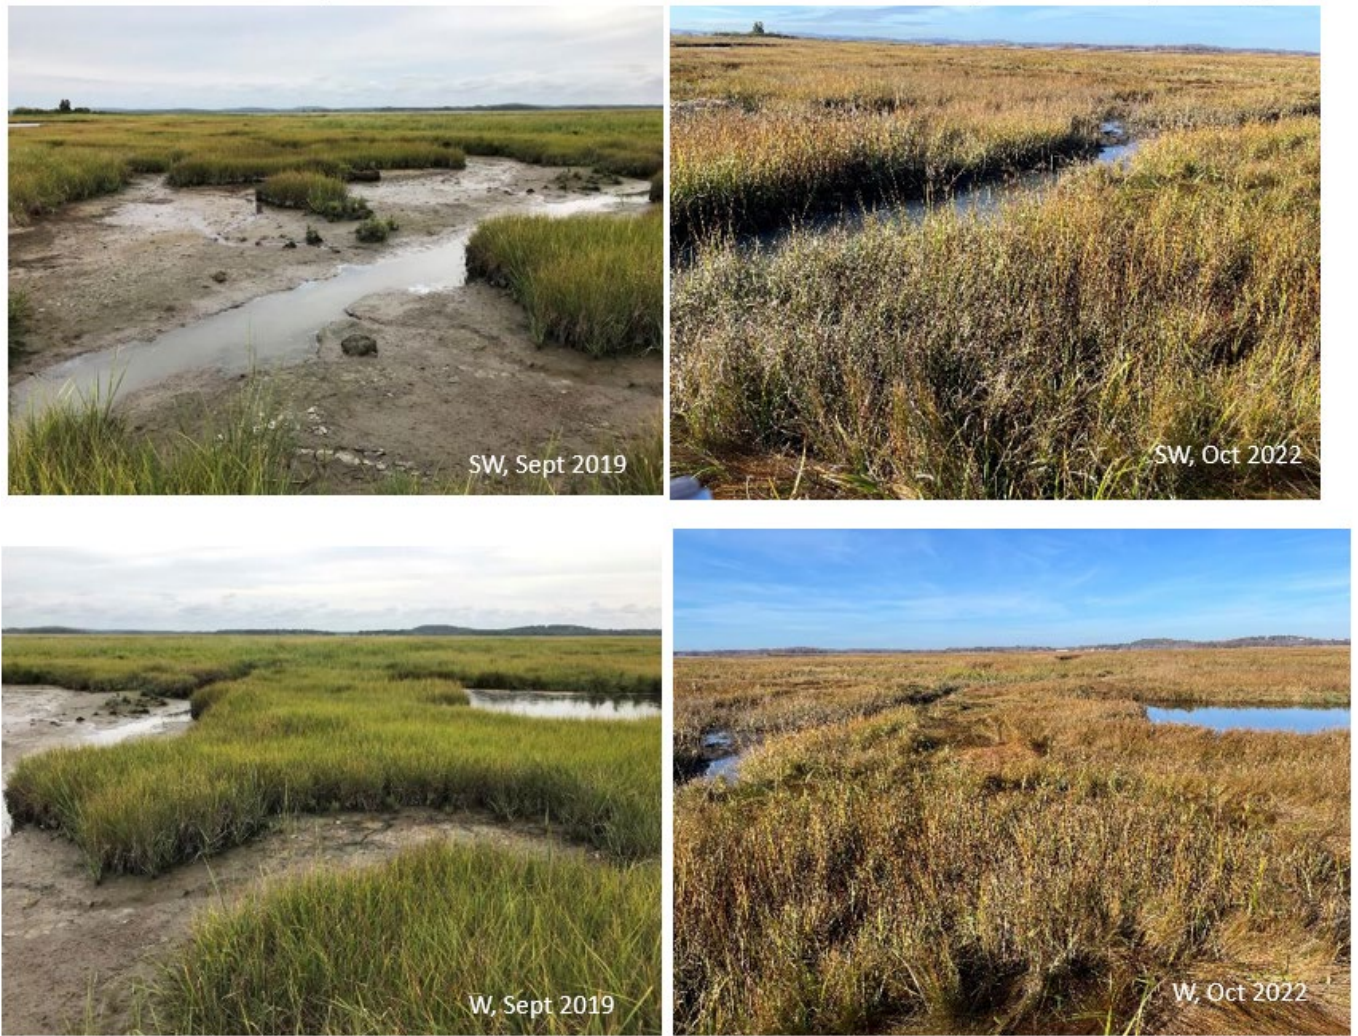
- Example 3: Two ditch plugs were removed in 2019 and two runnels were created in 2021 (see Figure 9).

*Figure 9. Photo station imagery of the ditch plug removal site before and after restoration (Example 3).*

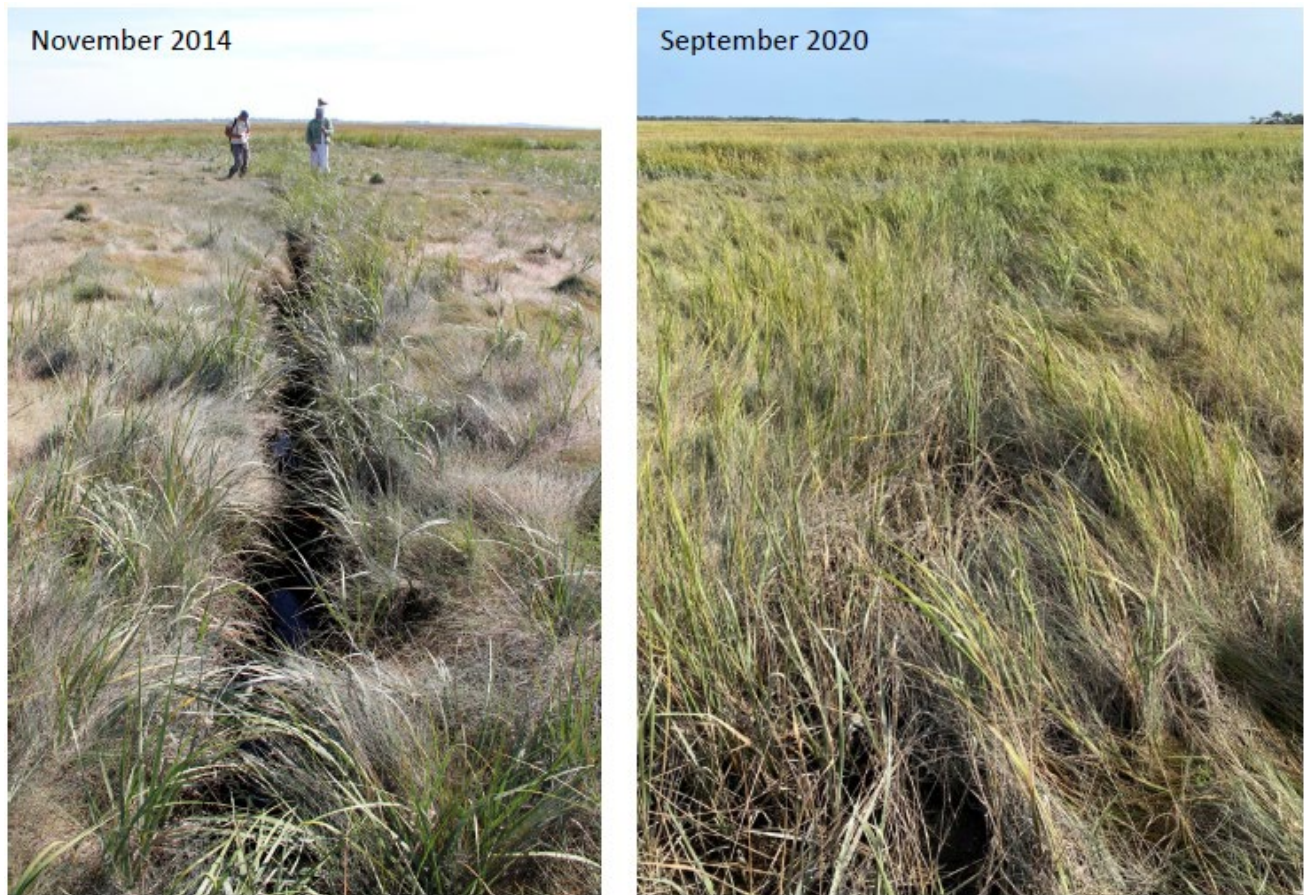
- **Ditch remediation:** We have not yet revisited ditch remediation photo stations since they were established in 2022 as the work was completed. Once additional photos are taken, we will be able to visually assess the marsh's response to this restoration. At this time, we can provide before and after photos from a 2015 ditch remediation pilot project (Example 5). Over the first three years following ditch remediation, treated ditches became shallower and more vegetated. *S. alterniflora* colonized ditches with the bottom above Mean Low Tide. Some ditches healed to 20 cm below marsh surface, while some healed to the marsh elevation. Detailed data is provided in Burdick et al. (2017). Figure 10 shows this progression from an open ditch in 2014 to revegetated peat in 2020, following the 2015 remediation.

Figure 10. A ditch before (left) and after (right) 2015 remediation. After remediation, peat developed within the ditch, and it thoroughly revegetated (Example 5).

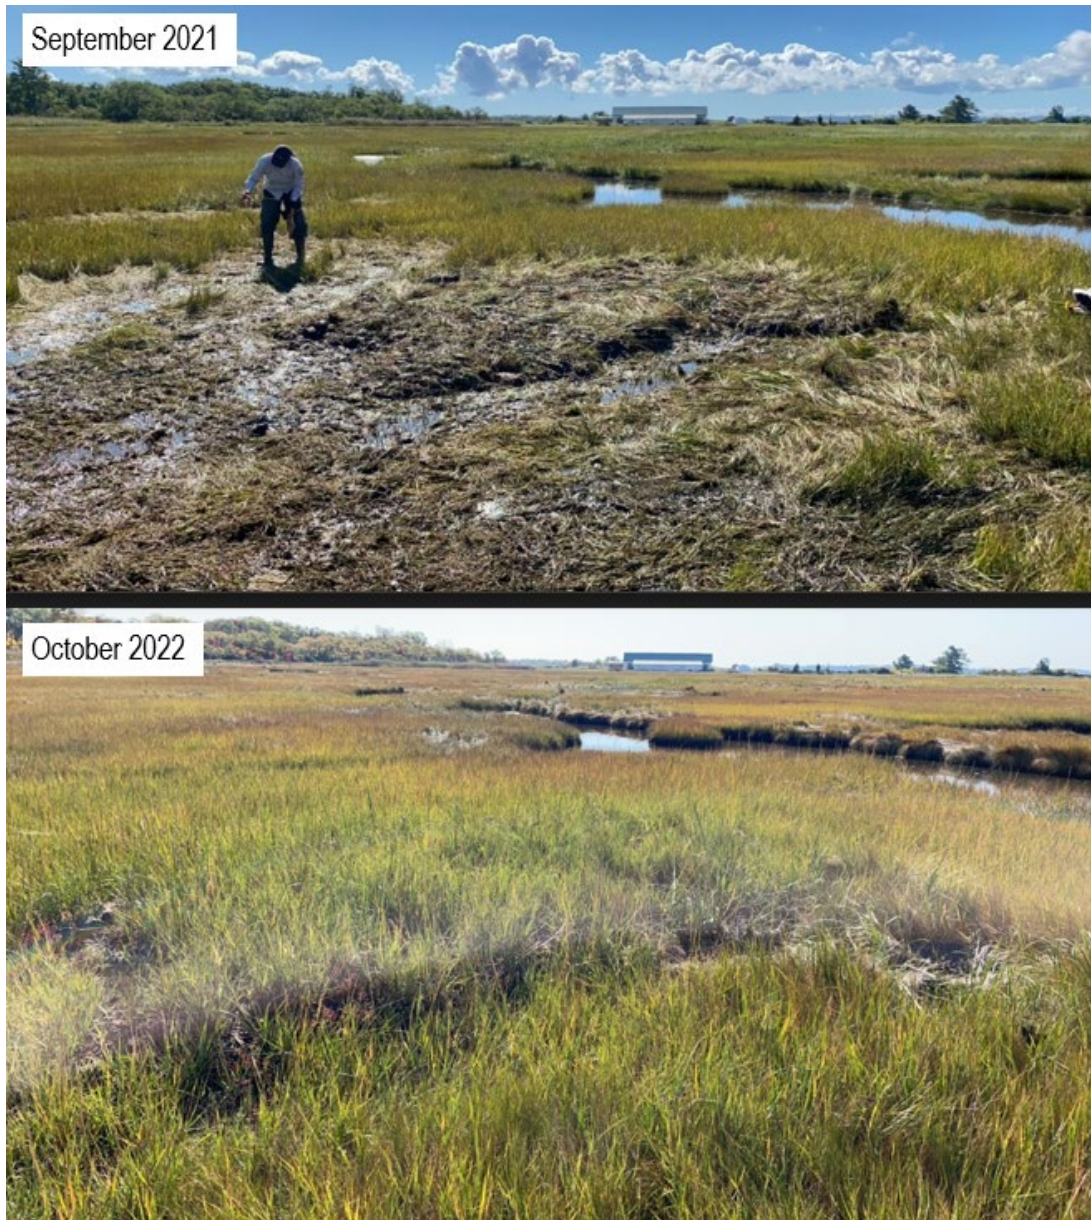
- **Microtopography Islands:** In addition to collecting measurement, vegetation, and inundation data on a subset of microtopography islands, we will also document their progression with photos. Figure 11 below shows an island (ISL\_SUOM\_015) created in September 2021 (Example 4). In September 2021, the island was dominated by *S. alterniflora* with no thatch and some bare areas. In October 2022, while still dominated by *S. alterniflora*, the island is nearly completely covered in vegetation, including additional species such as *D. spicata*, *Suaeda* sp., *S. patens*, and *Salicornia*. In addition, the vegetation data reported moderate thatch cover for this island.

Figure 11. A microtopography island composed of removed ditch plug material immediately after creation (2021) and a year later (Example 4).
